# TROY BRIDGE EXCAVATOR INCIDENT

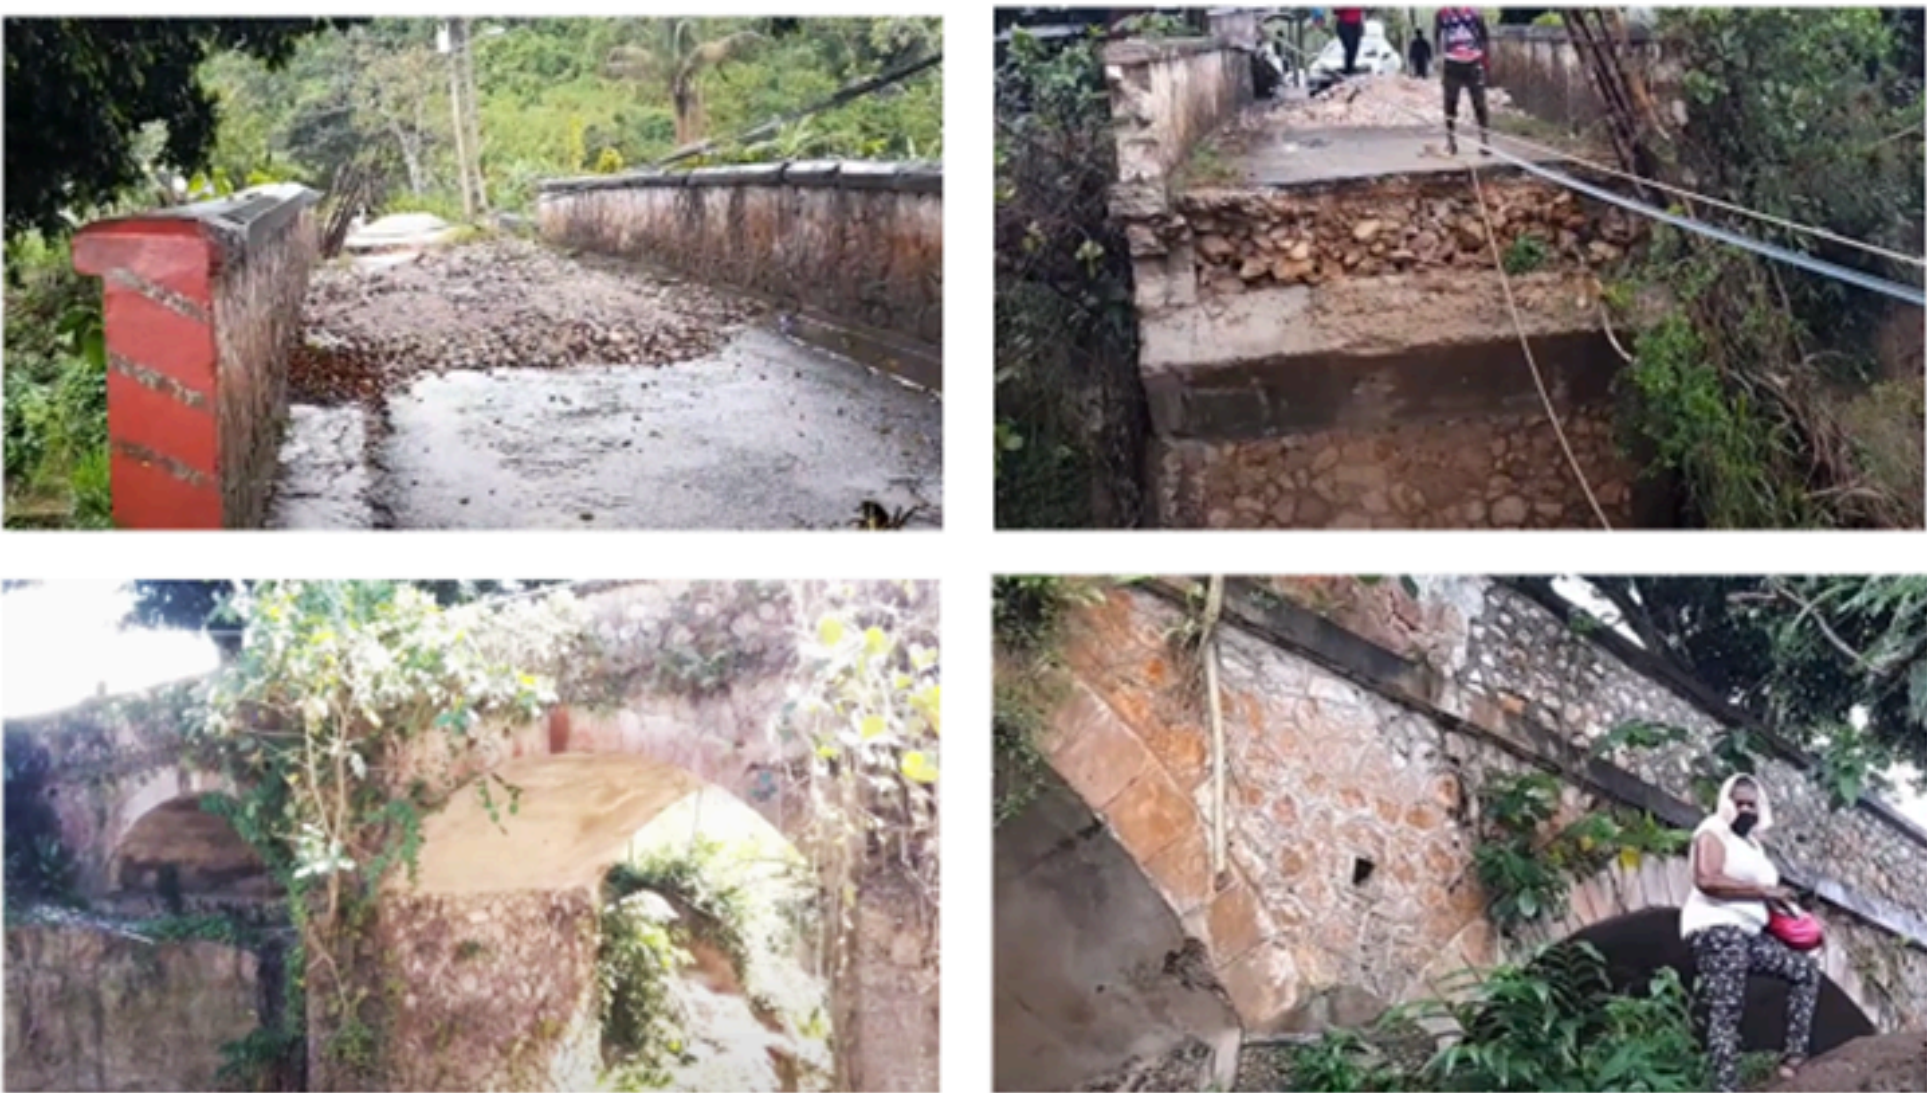
A contract was recently awarded for the reconstruction of a new bridge to replace the old bridge across the Hectors River, which partially collapsed in 2021. The old bridge which was originally constructed in 1869, is described as a “Barrel Arch.” Details of the Contractor and the construction team were not provided in the news reports. Photos of sections of the old bridge are below.

**Figure 2. Images of the remnants of the bridge.**

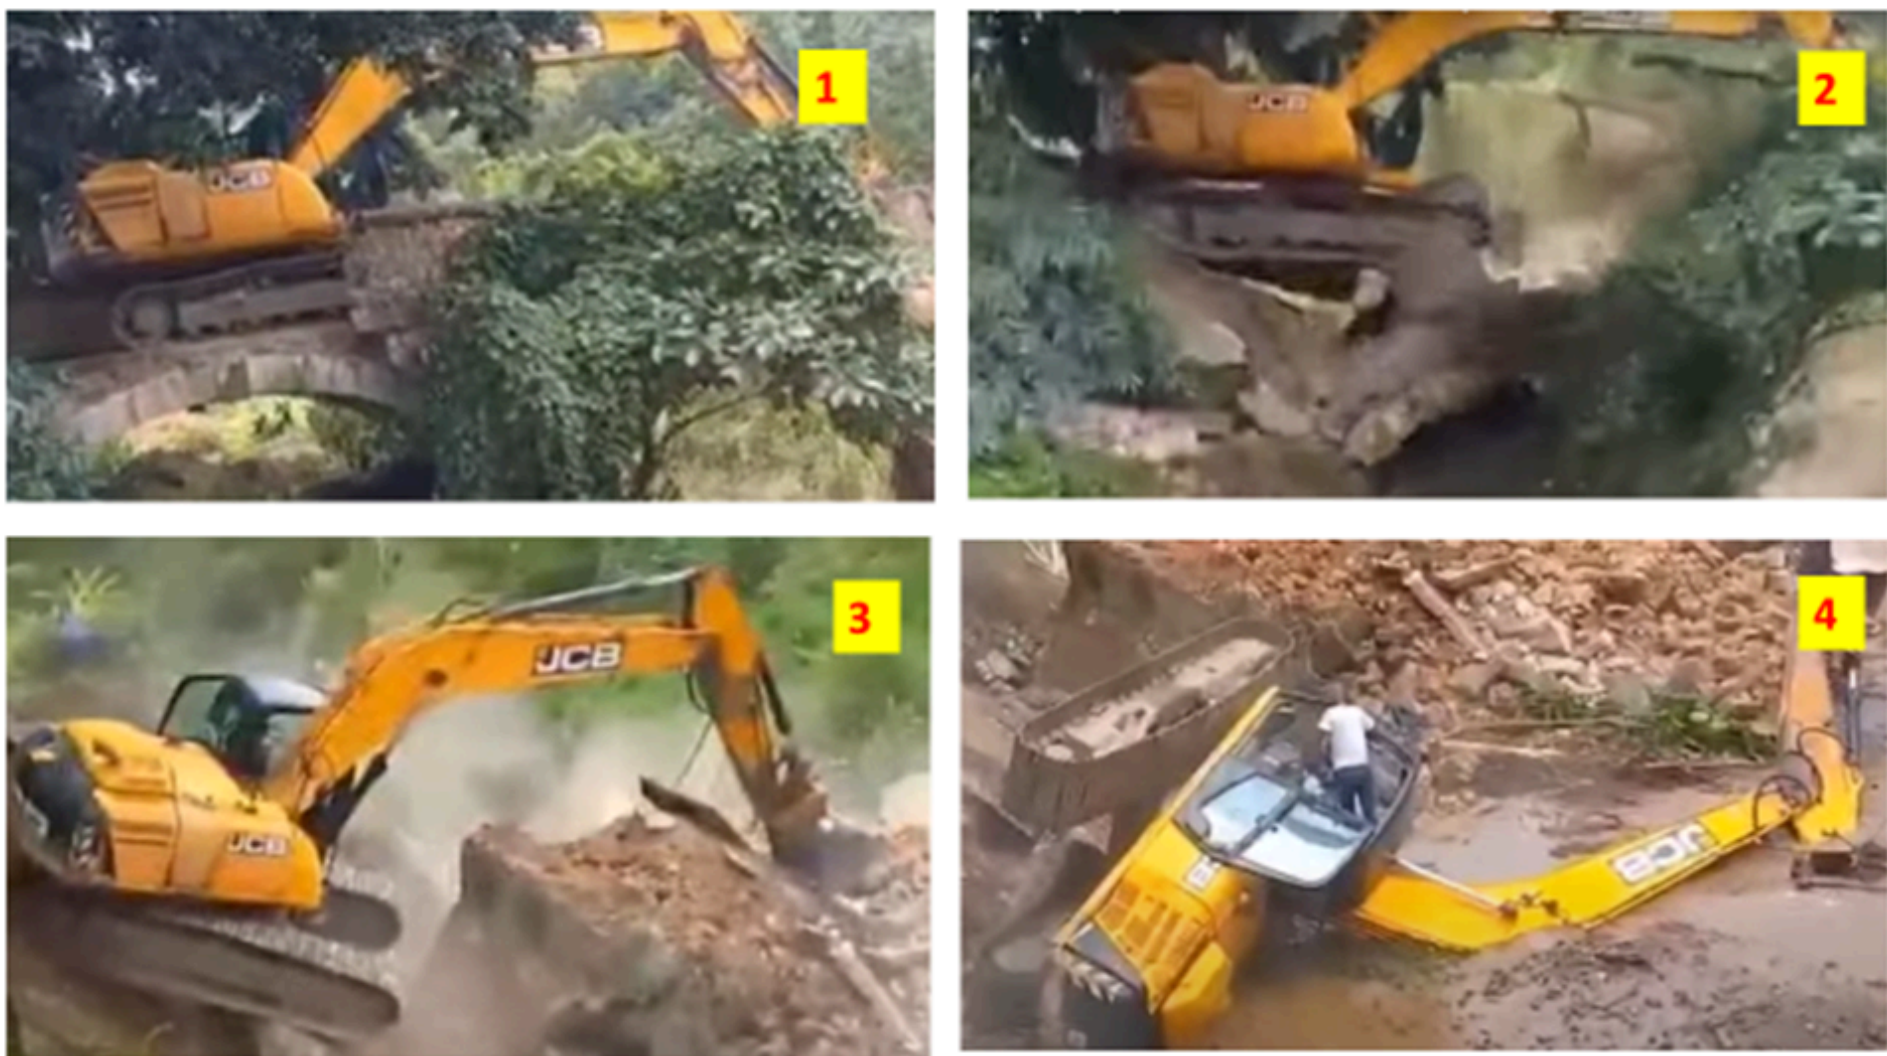
The result of the excavator going onto the compromised bridge structure was predictable. The bridge collapsed and the excavator fell into the river.

**Figure 4. Sequence of the collapse of the arch and the excavator falling into the river. In image 3, the operator is trying to stabilize the unit using the bucket, however this is futile.**

Fortunately for the operator, it fell on the right side. Had it fallen on the left (cab) side, the results could have been different. The operator could have been:

1. A proper hazard assessment must be done prior to starting work with machinery on any site. This must take into account ground (and in this case bridge structure) conditions, and specification of the equipment.
2. Expect the expected. An old compromised bridge cannot support the weight of a 24 ton excavator. No amount of gentleness of operation would have made a difference.
3. Work must be supervised by competent persons. The video suggest an operator operating alone.
4. The operator must be trained in emergency operating procedures. If the machine had toppled on his side (left), the entry door would have been stuck in the river bed.

There is no exit through the right side of the machine so the operator’s only escape routes would be through the front glass, the rear glass or the skylight on top of the cab. These would not be popping open as easy as in the Caterpillar unit in the movie, so unless the operator is prepared with a device to assist with damaging the rubber seal to allow the glass to be removed, he could well be trapped and unable to help himself to leave the cab.
